NUMBER: 09-011-22

Cold Engine Ticking Noise From Exhaust Manifold Area

2019 - 2021 (DT) Ram 1500 pickup

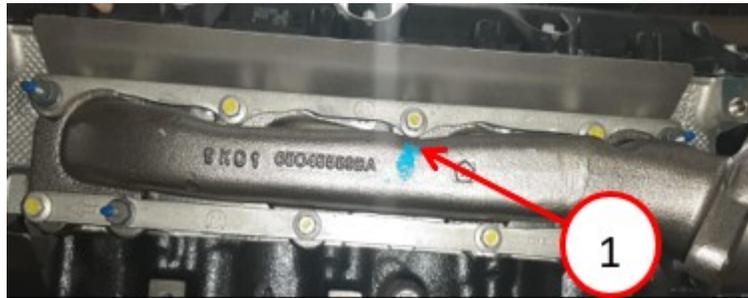
Fig. 1
Exhaust Manifold Crack Area

5. Visually inspect for a cracked manifold and confirm it is not a casting parting line or casting fin in location shown. (Fig. 1)

1- Manifold Crack Area

6. If a cracked manifold is found, replace the exhaust manifold(s) that are cracked. Refer to the detailed service procedures available in DealerCONNECT>Service Library under: 09 - Engine, 5.7L / Manifolds / Manifold, Exhaust / Removal and Installation.
